A Case Study on Cloud burst induced Landslide

Abstract— The devastating landslide which took place at Kadavoor, Kothamangalam on August 17, 2012 shook the lives of many. More than seven families lost their homes and the death toll touched seven in this catastrophic incident. In order to find out the root cause of the landslide, many site visits were conducted and soil samples were collected from 4 different cordon points, with an objective to classify the soil type and determine its cohesion and angle of internal friction. The soil parameters were found out by conducting laboratory tests. Simultaneously, the longitudinal profile of the slope was surveyed and slip circles were plotted for various sections and soil types and minimum factor of safety is determined.

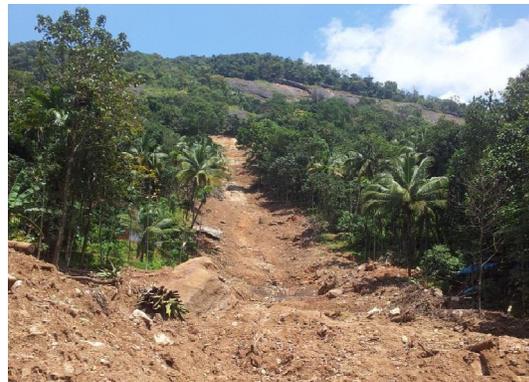
Figure 1 Site at Kadavoor

Some other alternative mechanisms can be invoked to explain the phenomenon. For instance, the mechanism of gradual “smoothing” of the sliding surface was proposed by Kokusho (not for the Kadavoor landslide). He supposed that when a soil layer of significant thickness underneath the sliding surface liquefies, and the soil directly on top is of low permeability (both conditions might also apply to the Kadavoor landslide), then the natural tendency of the liquefied layer to settle could produce a very slim “film” of water, only a few centimeters or even millimeters in thickness. The development of this water film along the sliding surface could explain the extent of the runoff (about 100 m). Figure 1 shows the site at Kadavoor where the land slide occurred.

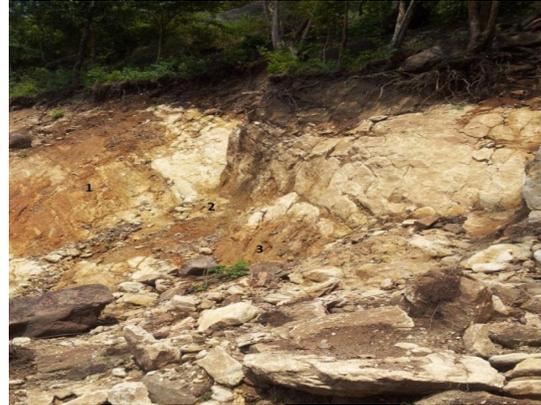
Figure 2 Site spots for sampling

Soil sample was taken from 4 cordon points Figure 2. The fourth sample was taken at a point located in the top right corner of the slope which hadn't slide off due to the landslide. The soil samples were classified after conducting wet sieve analysis. Important soil parameters like cohesion and angle of internal friction was found out from direct shear test. The longitudinal profile of the slope was obtained after conducting survey.
